AEROBEE 150 PROPULSION FAILURE

by J. R. Busse and P. S. Bushnell, Jr.

*Goddard Space Flight Center
Greenbelt, Md.*

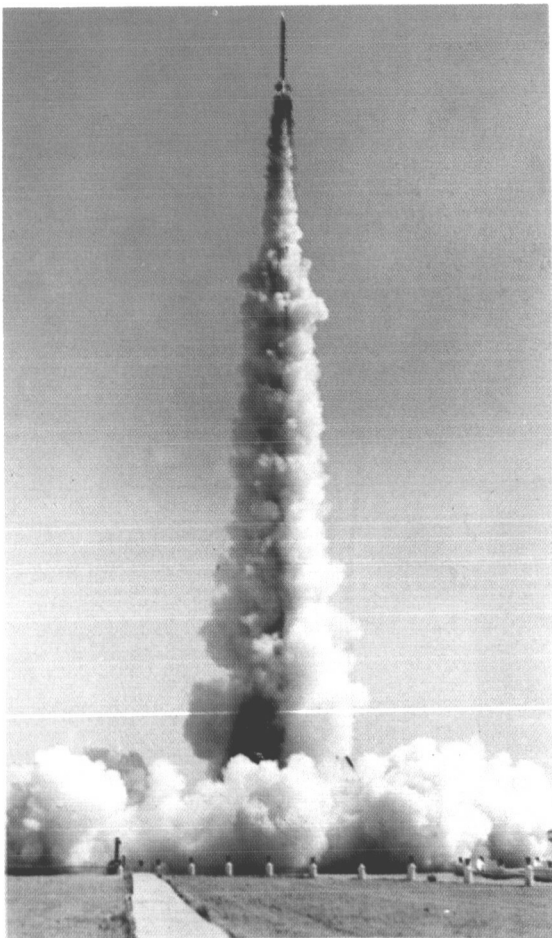
Figure 1—NASA 4.113 GA-GI launching from WSMR.

The color photograph of the launch, (Figure 1) clearly illustrates the unusual colored exhaust which lasted through the flight. Also, excellent black-and-white films taken the first seconds of launch provided detailed views of the vehicle going up the tower. The sequence in Figure 19, taken at the rate of 20 frames per second, indicates the hard start. Note the shape of the flame, and also the abnormally large flash, which was a result of high-pressure start conditions.

Compare the normal flame in Figure 2 of Aerobee 4.67 NP with the flame in Figure 1 of NASA 4.113 GA-GI. The flame in Figure 1 is shorter but wider, and the booster is almost obscured from view by the dense smoke which starts well forward of the booster. Normally, the booster fins are easily identifiable since the normal gray-white smoke comes from the booster. However, it is seen in Figure 1 that the smoke, instead of the normal orange flame, also came from the sustainer motor.

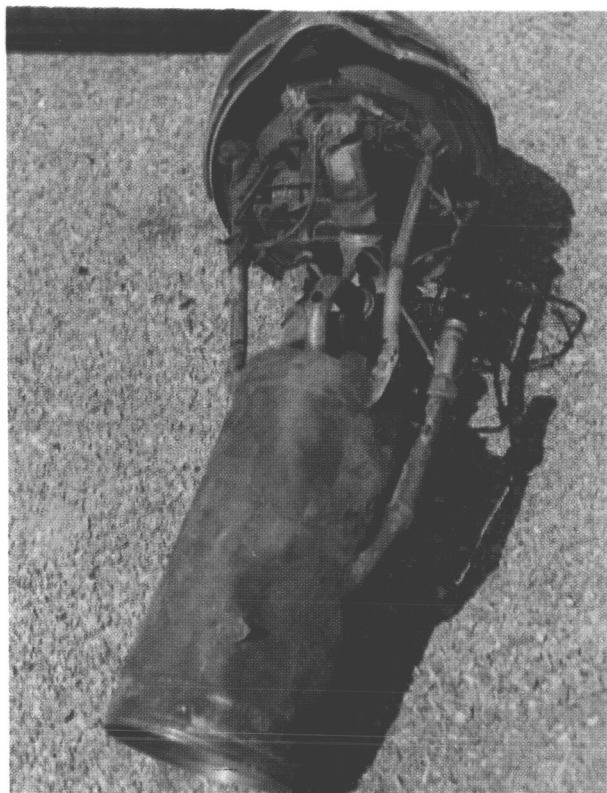
Figure 3—Aft bulkhead of fuel tank and thrust structure of motor after removal from tankage.

Clearly visible in Figure 3, which shows the aft bulkhead of the fuel tank and the motor thrust structure, is an aniline residue on the outside of the thrust chamber. The fuel line is broken just

between the B-nut and the attachment to the fuel tank bulkhead. Subsequent metallurgical analysis of this fracture at GSFC substantiated the assumption of an impact fracture of this piece.

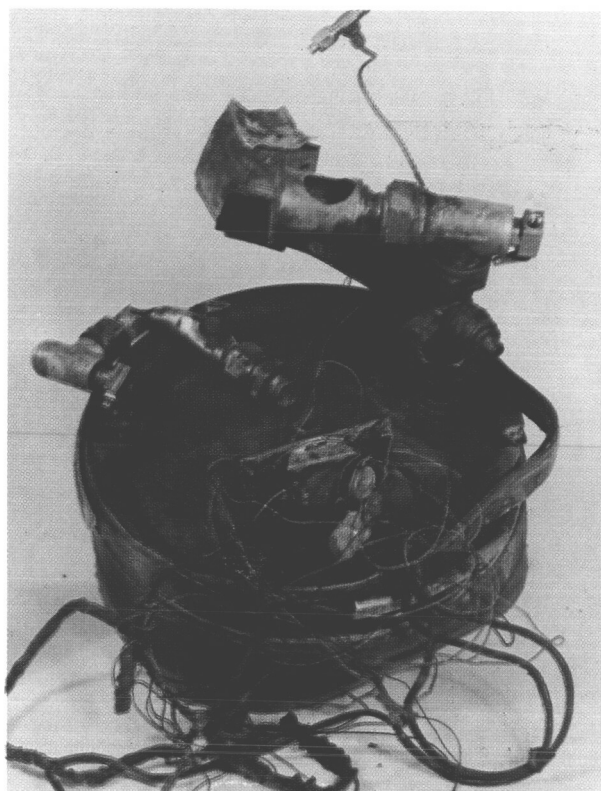
Figure 4—Fuel tank bulkhead separated from the tankage.

Figure 4 also illustrates this bulkhead covered with a burned aniline residue, except in the area in line with the chamber pressure connector. The chamber pressure connector and the control and instrumentation wiring were clean and showed no traces of heating. The plumbing was coated with the aniline residue, the heaviest coating appearing on the forward side of the components. There was little or no residue on the under side. Residue was also noted on the edges of the hole created by the missing fuel tap and the broken chamber pressure tap was heavily coated (a diagram of the propulsion system identifying the various parts discussed in the report is given in Figure 5).

Also, it was observed that a portion of the chamber pressure tap and B-nut were missing (Figure 4). In addition to a break in the fuel line at the base of the fuel tank, a tap on the fuel coolant outlet line of the thrust chamber was missing. The squibs in the shutoff valves were unfired. The parts were submitted for metallurgical analysis.

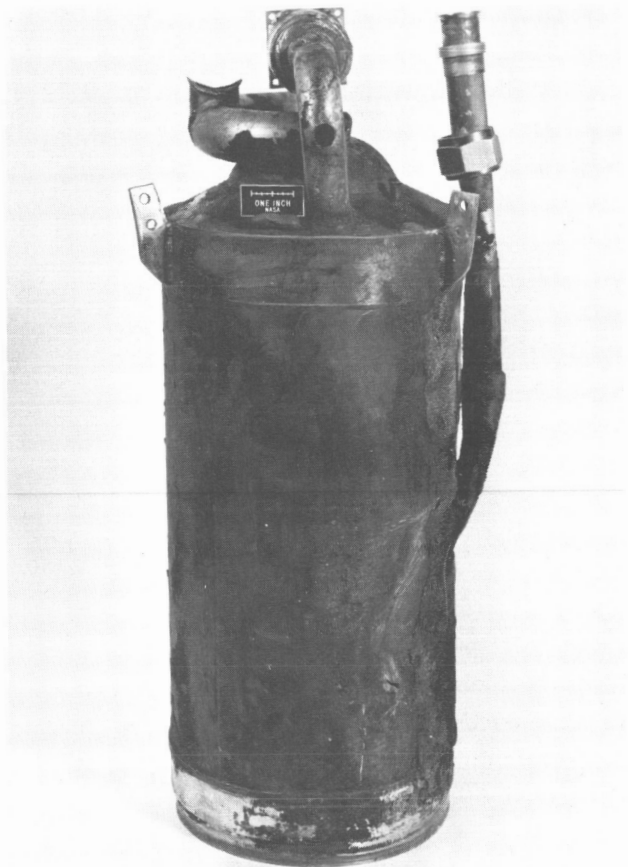
Figure 6a shows the rocket motor after removal. Figure 6b is a close-up view illustrating the missing tap on the propellant line from the coolant jacket to the fuel injector, and the broken chamber pressure tap covered with the residue. Metallurgical analysis at GSFC of the mode of fracture of the propellant line tap indicated that it failed by application of a force in the opposite direction to the force that would have been applied by impact, a fact which was instrumental in establishing the failure of the tap during the hard start and in explaining subsequent performance.

Figure 6a—Rocket motor after disassembly.

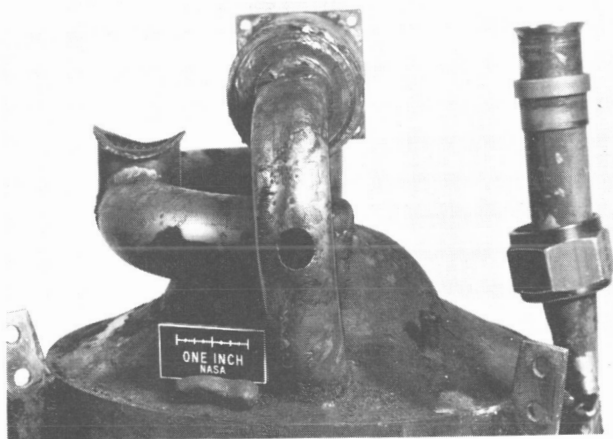
Figure 6b—Close-up view of damage sustained by rocket motor.

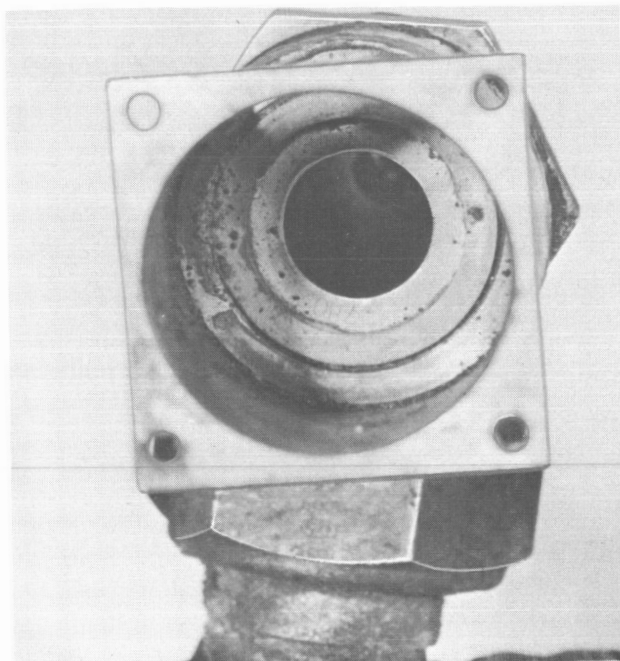
Figure 7—Mixture ratio orifice.

The mixture ratio orifice (Figure 7) was still in its proper place and of the proper size (0.78 in.). Also, it may be observed that the outer ring on the oxidizer burst diaphragm was still intact in its proper position. The fuel and oxidizer strainer cages (Figure 8) were inspected. A trapped "O"-ring that was dislodged from the fuel shutoff valve may be seen in a close-up view of the fuel strainer in Figure 9. The shutoff valves were in the open position.

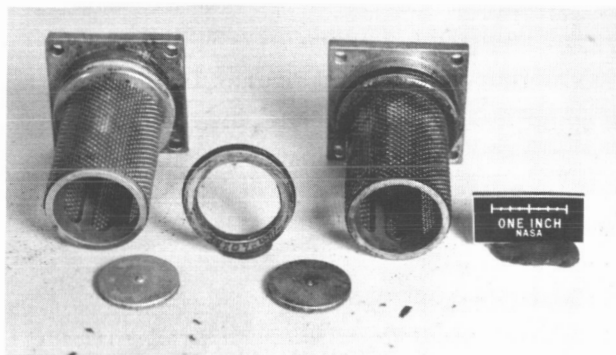
Figure 8—Fuel and oxidizer strainers.

The previously noted displacement of the O-ring from the pintle of the shutoff valve (Figure 8) could not be related in any way to the failure of 4.113 GA-GI but did point up a serious design deficiency in the fuel shutoff valve, used to conserve helium gas on attitude control system flights, which has been remedied by employing a new shutoff valve seat.

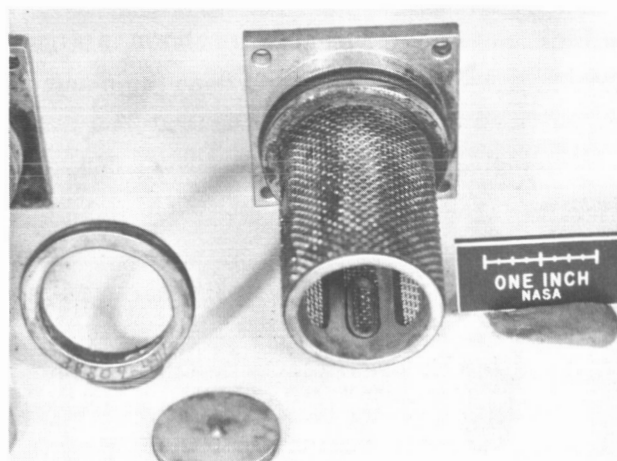
Figure 9—An "O"-ring wedged in the fuel strainer.

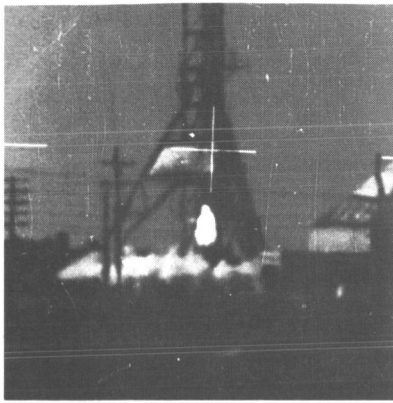
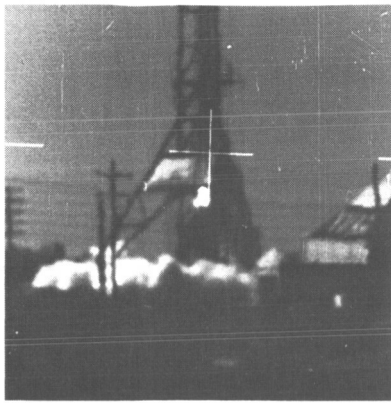
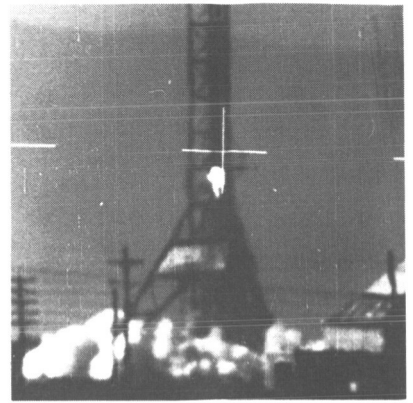
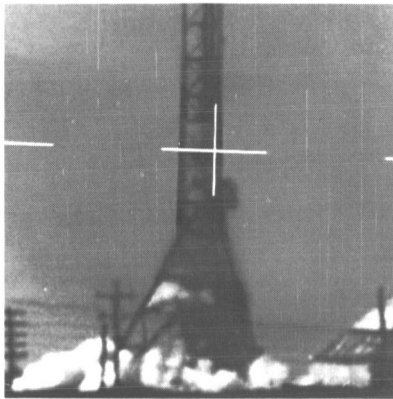
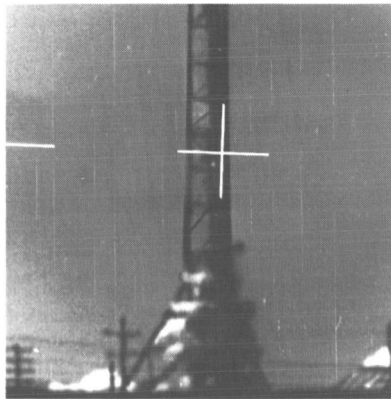
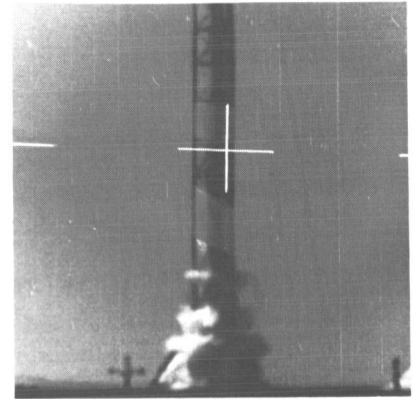
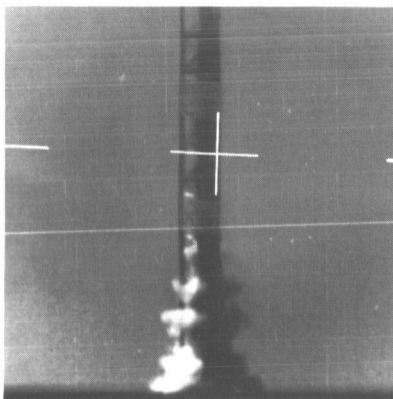
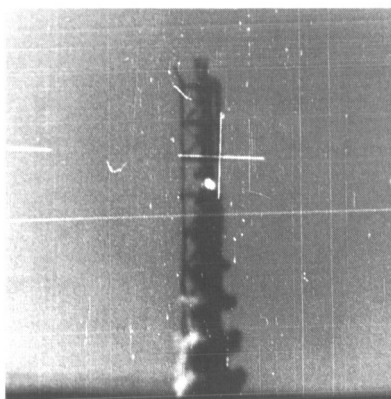
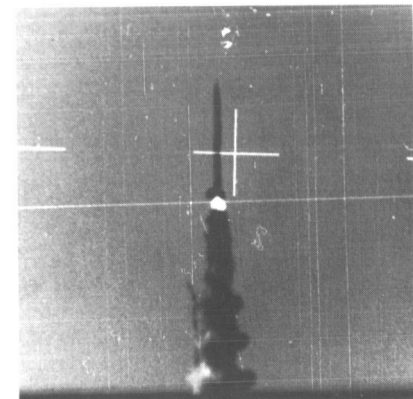
Figure 19—Sequence (20 fps) of NASA 4.113 GA-GI lift-off.

films. At approximately 0.55 to 0.60 seconds, the sustainer flame apparently went out, but again became visible at 0.65 seconds and lasted until 0.70 seconds (note frames d, e, f, g in Figure 19). At this time, as indicated by color photographs, the smoke from a residual sustainer flame had become a dark reddish brown. When the rocket left the tower at 0.95 to 1.0 seconds, it was still emitting a dense cloud of reddish brown smoke. On the basis of its color and the characteristic odor present in the air, observers concluded that the smoke was rich in IRFNA (inhibited red fuming nitric acid).

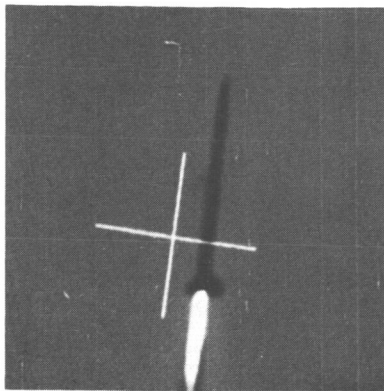
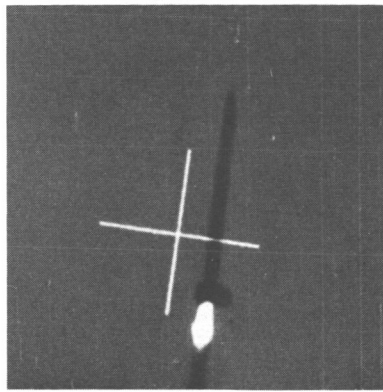
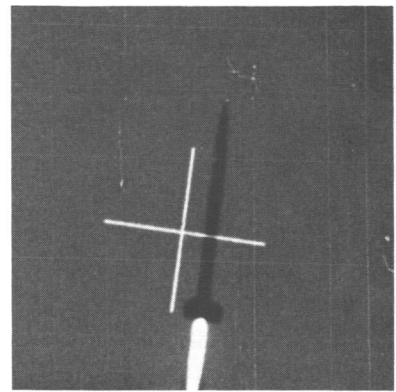
Figure 20—Sequence of pulsating flame.

At approximately 2.5 seconds, the booster separated, after which the sustainer flame pulsed (alternate short flame, long flame, see Figure 20) at 10 cps and continued to burn with a reddish brown smoke that faded to a pale yellow-white at approximately 20 seconds. At approximately 25.05 seconds, a "puff" was observed. Other such puffs were observed at 25.4, 25.8, 26.3, 26.75,

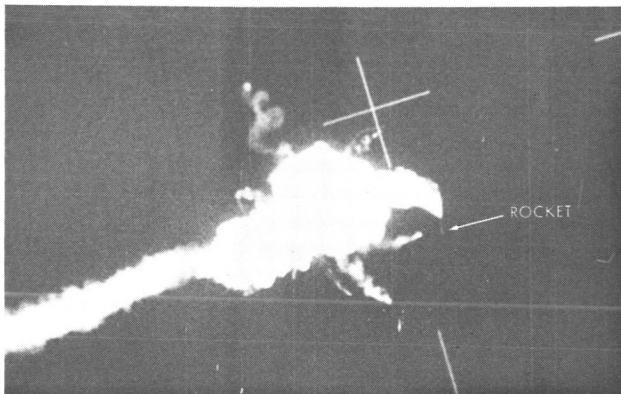
Figure 21a shows the tail can explosion at 27.4 seconds. Notice the angle of the rocket just after the explosion. Figure 21b is a view of the explosion from another tracking camera taken about 1/2 second later. Notice in this view also that the rocket is traveling almost sideways.

Figure 21a—Tail can explosion (+27.4 seconds).

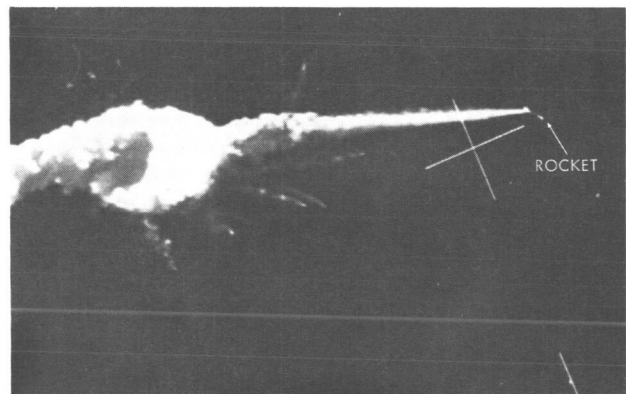
Figure 21b—Tail can explosion (film from another camera at approximately +28 seconds).
